Rattlesnake Creek Conceptual Rehabilitation Plan

Prepared for:
Asotin County Conservation District
720 6th Street, Suite B
Clarkston, WA 99403

Prepared by:
Sage Environmental Research, LLC
February 2018

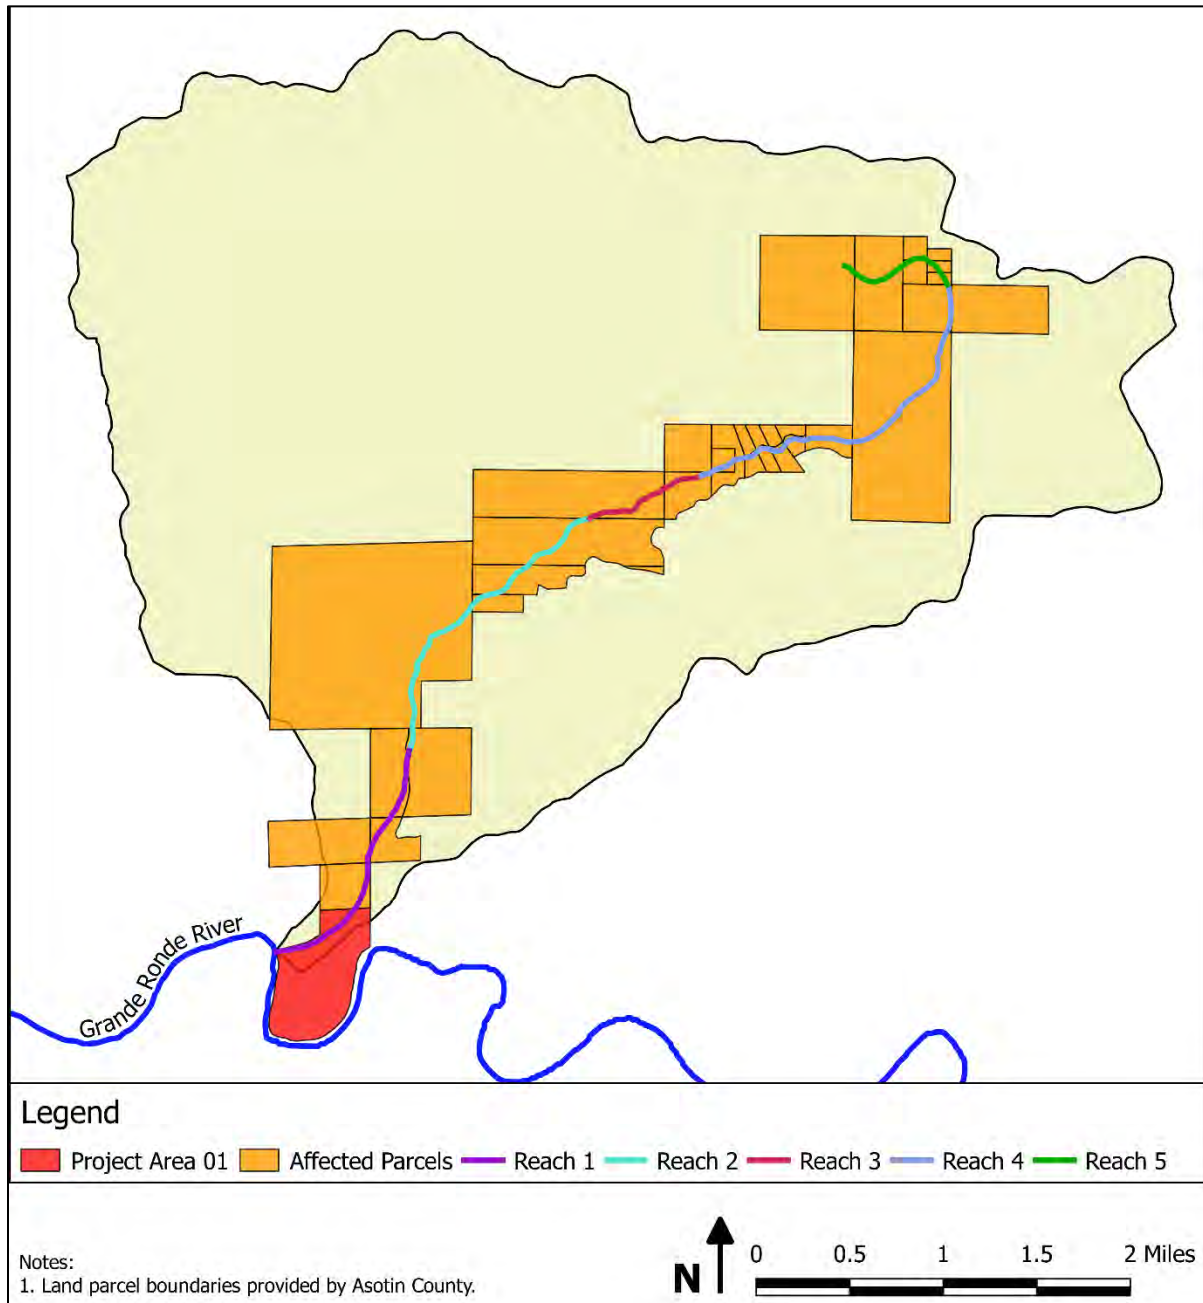
Figure 1. Location of Project Area 01 within the Rattlesnake Creek basin.

Project Area 1 (PA-01) is located from the confluence of the Grande Ronde (RM 0.0) to RM 0.5 (Figure 1). The channel is characterized as a confined, low sinuosity, step-pool and plane bed assemblage, heavily influenced by boulders and bedrock ledges. Highway 129 likely has little influence on the planform and behavior of the creek, but likely has some influence on sediment contribution. Multiple bedrock and boulder ledges are exposed and are potential fish barriers

Recommendations for PA-01 are to remove the barrier caused by the fan at the Grande Ronde confluence, improve fish passage at potential boulder and bedrock barriers, move lodged LWD back into the channel and floodplain, riparian planting, and invasive vegetation control.

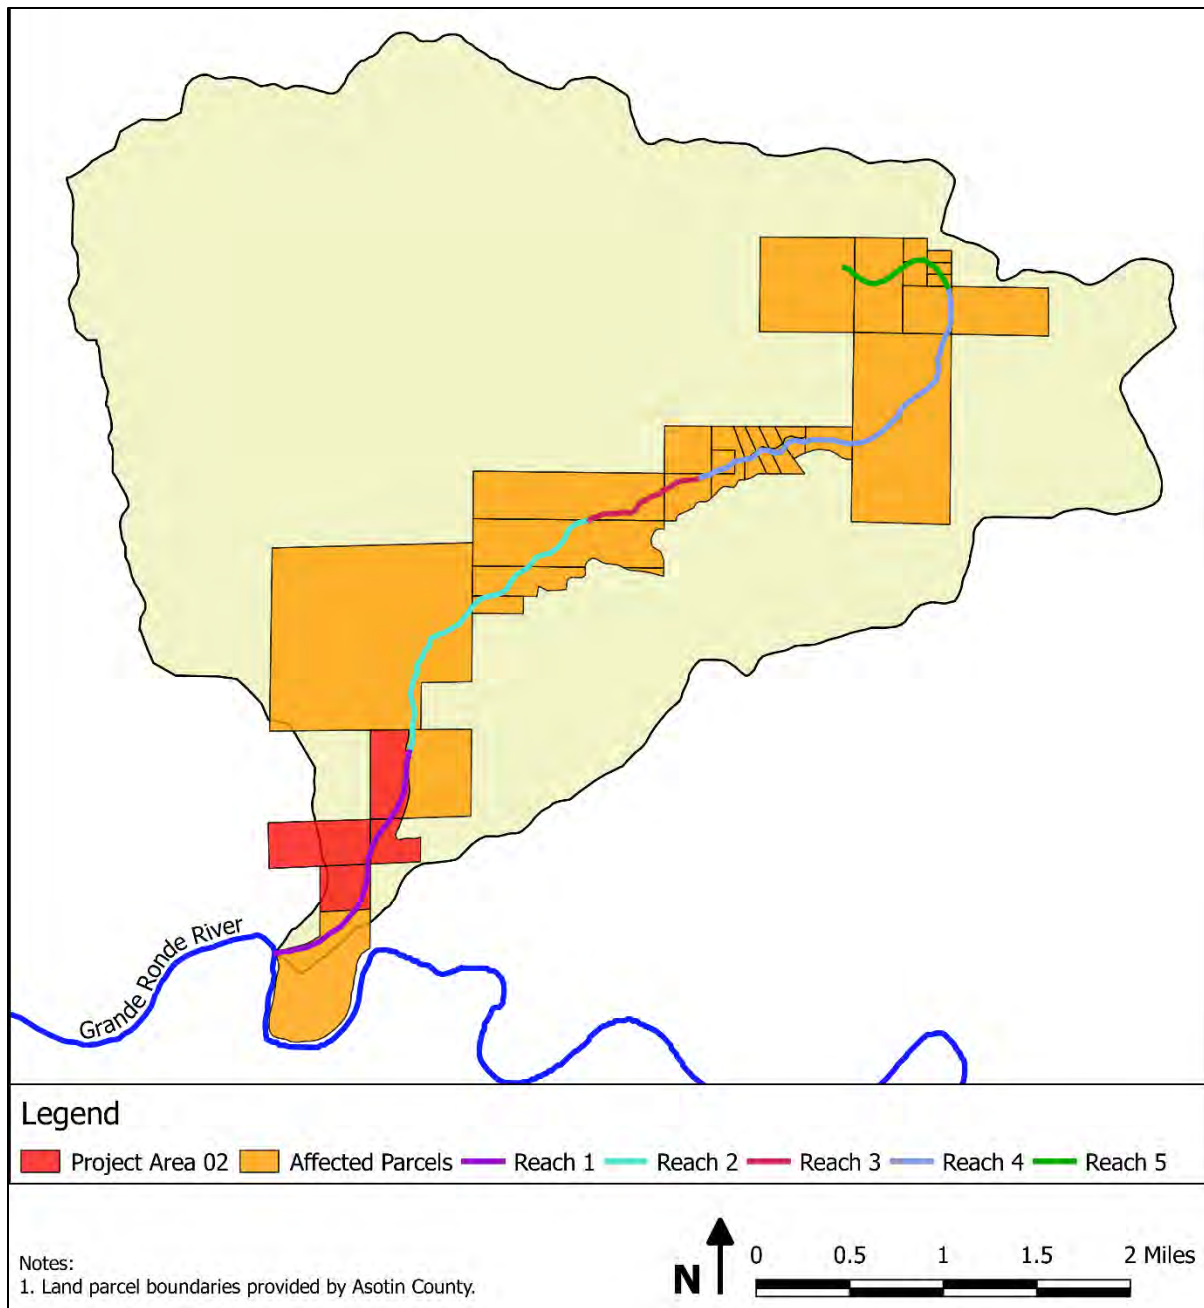
Figure 3. Location of Project Area 02 within the Rattlesnake Creek basin.

Project Area 02 (PA-02) is located from RM 0.5 to the Highway 129 bridge crossing at RM 1.45 (Figure 3). Confinement is variable, with relatively wide sections (Figure 4a) separated by brief bedrock canyons and deeply incised sections (Figure 4b). The creek flows alongside Highway 129, which increases confinement in localized areas near turnouts. Confined sections are dominated by a step-pool morphology forced by bedrock ledges and large boulders. Wider sections are dominated by a plane bed morphology with occasional multiple threads and brief pockets of diverse hydraulics forced by boulder ribs.

Canopy tree species in the valley bottom are rare for most of PA-02, consisting of alder and ponderosa pine near the valley margin, except for the upper 0.1 miles which appears to have been protected from the flood by the Highway 129 bridge. There are approximately 370 pieces of LWD lodged on the toe of the hillslope above the valley bottom, and near the floodplain margin.

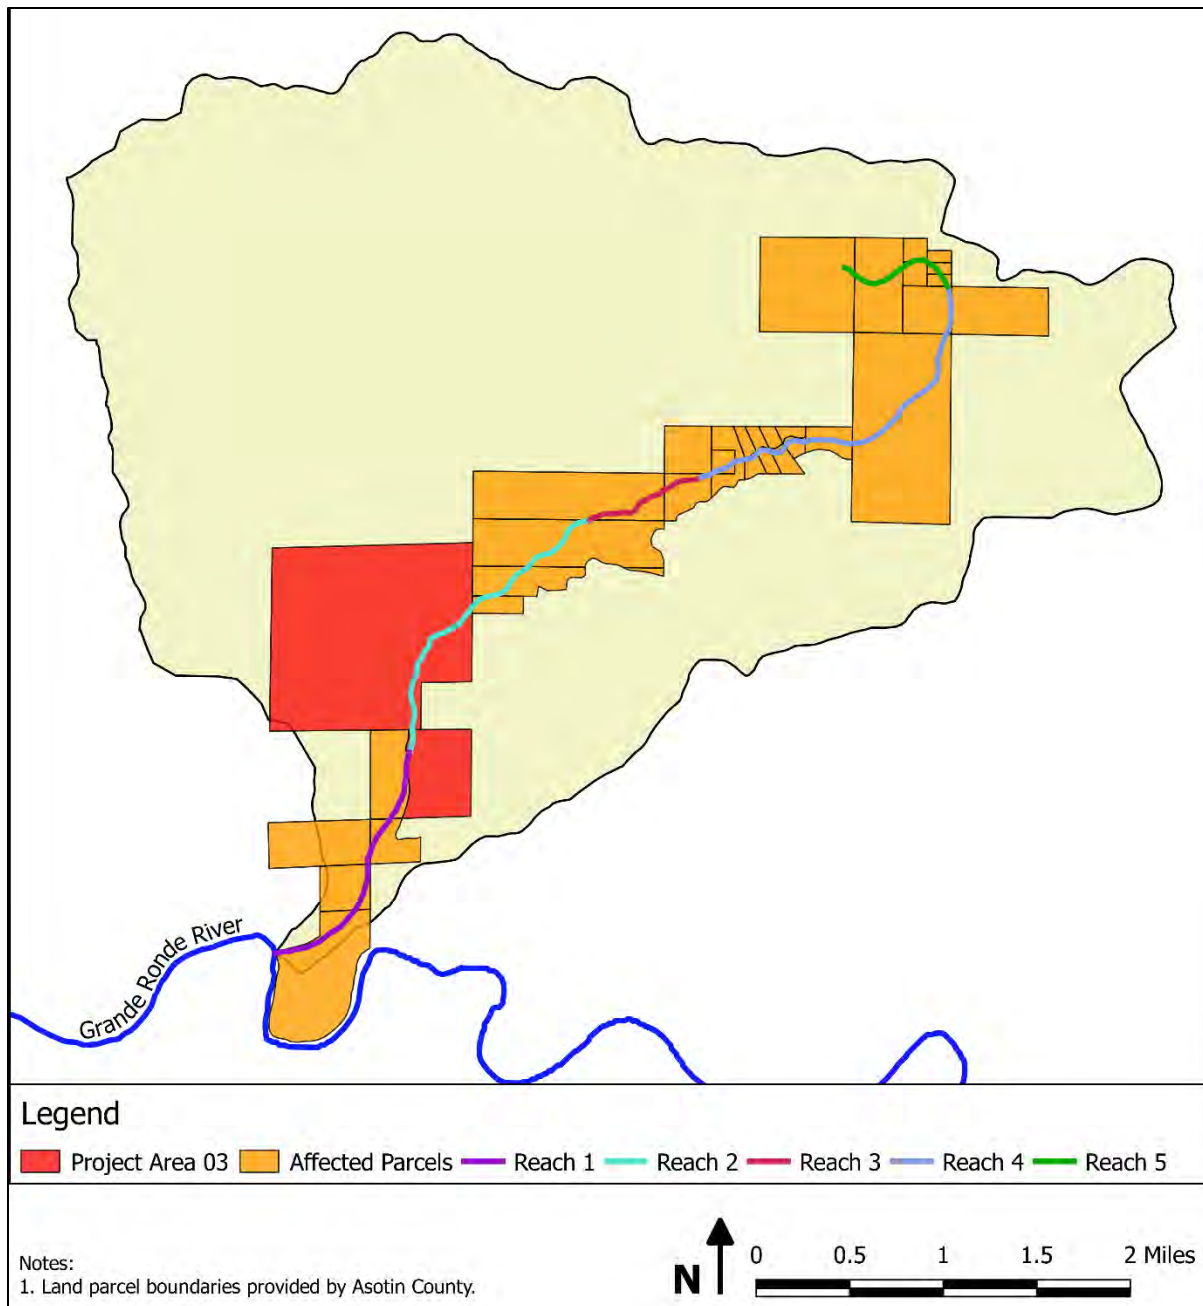
Figure 5. Location of Project Area 03 within the Rattlesnake Creek basin.

Project Area 03 (PA-03) is located from the Highway 129 Bridge crossing at RM 1.45 and ends at RM 2.4 (Figure 5). The channel is characterized as partly confined, low-moderate sinuosity, dominated by rapids, runs, and step-pool sequences (Figure 6a and b). In its current condition, channel incision varies. Incision is typically highest downstream of knickpoints created by recently exposed bedrock ledges, and gradually lowers downstream until the next knickpoint. The West Branch of Rattlesnake Creek enters the reach at RM 1.7, contributing a substantial proportion of Rattlesnake Creek's drainage area and discharge. Sediment and LWD at the mouth of the West Branch of Rattlesnake Creek has created a fish passage barrier, restricting access to relatively undisturbed habitat (Figure 6c and d). Near RM 1.75, a significant bedrock ledge and boulder pile is likely a fish passage barrier to upstream reaches on the mainstem of Rattlesnake Creek. Approximately 600 pieces of LWD are lodged on the toe of the hillslopes and valley bottom margin.

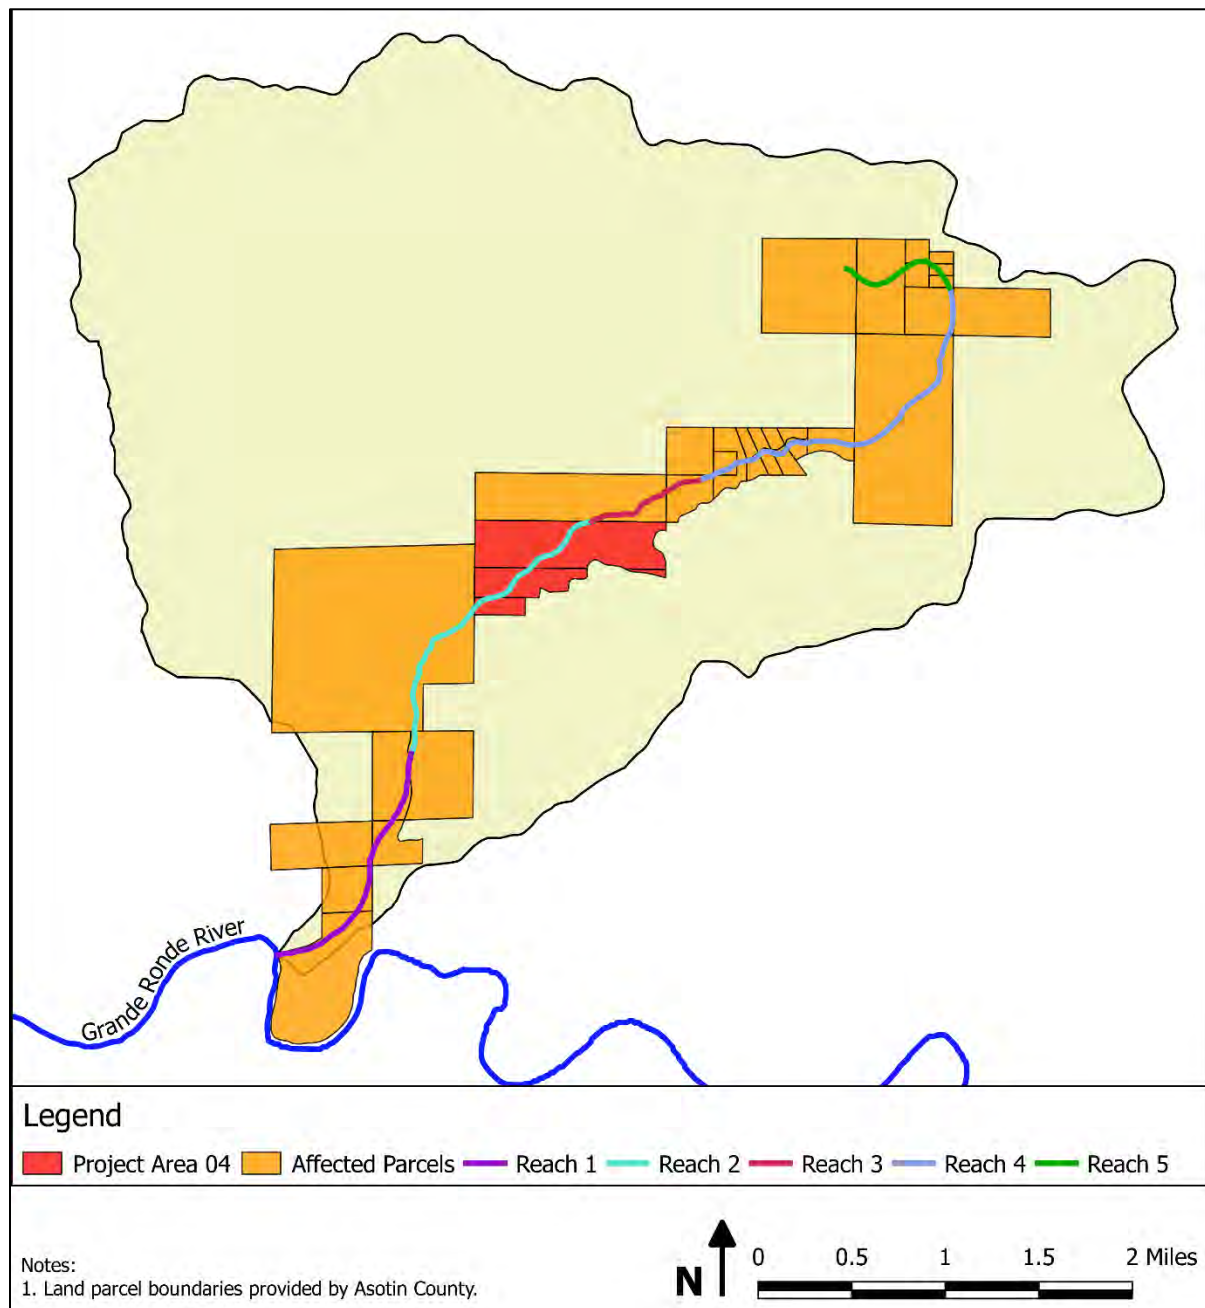
Figure 7. Location of Project Area 04 within the Rattlesnake Creek basin.

Project Area 04 (PA-04) is located from RM 2.4 to an unnamed tributary at RM 3.3 (Figure 7). The channel is characterized as partly confined, low sinuosity, dominated by runs and rapids separated by bedrock ledges. Geomorphic impacts from the flood are glaringly evident. Whereas downstream reaches were clearly impacted, resulting in the loss of riparian vegetation and

topsoil, removal of LWD, and segments of rapid incision; the channel in PA-04 and the reaches upstream is also heavily impounded by excessive sediment (Figure 8a). Large boulder/cobble berms and sheets cover the entire valley bottom, and the main channel is not well-defined. Substrate in the valley bottom is loose and composed mostly of large size classes, allowing the creek to go subsurface for relatively short segments. A small unnamed tributary on river left is cut off from the mainstem, and marks the top of PA-04 (Figure 8b). There are approximately 50 pieces of lodged LWD along the valley margin.

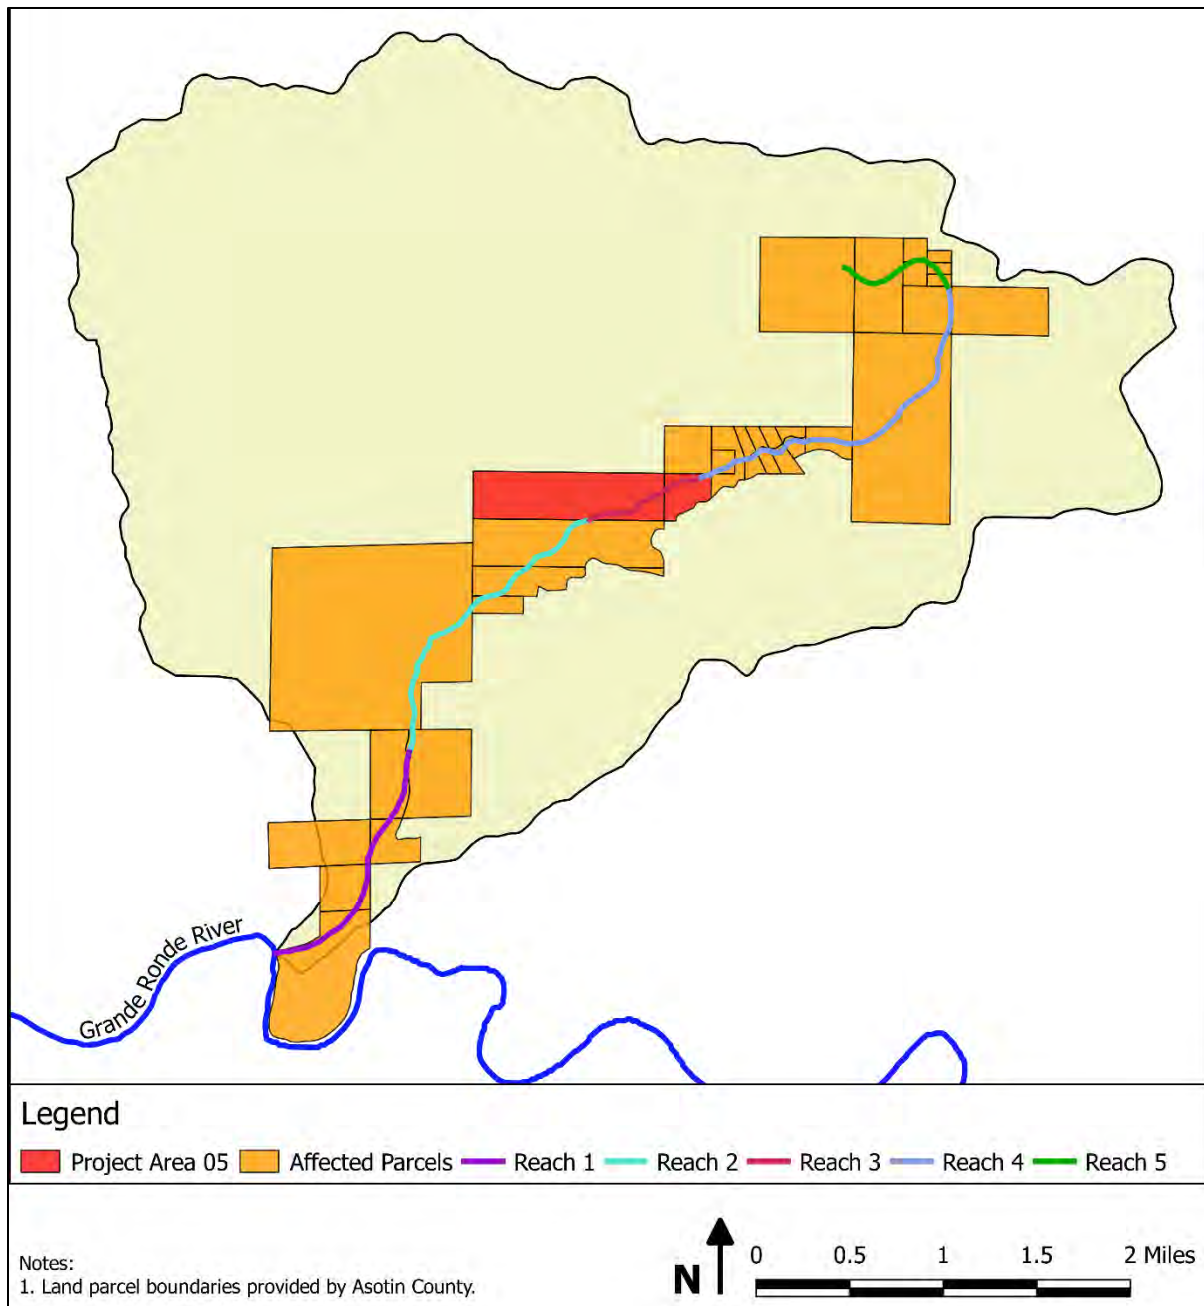
Figure 9. Location of Project Area 05 within the Rattlesnake Creek basin.

The channel in Project Area 05 (PA-05) is a steep, single-thread, channel dominated by plane bed morphology (Figure 9). There are several sections of low-gradient runs; however, steps, cascades, and rapids skew the overall gradient through the reach. Massive chunks of the bedrock wall fell into the channel creating a substantial vertical drop and fish passage barrier at the bottom of PA-05. A LWD jam racked onto a boulder sheet and live trees at RM 3.65 create a pitched channel, splitting the flow roughly 50/50. There is nearly a six-foot elevational difference between the split channels.

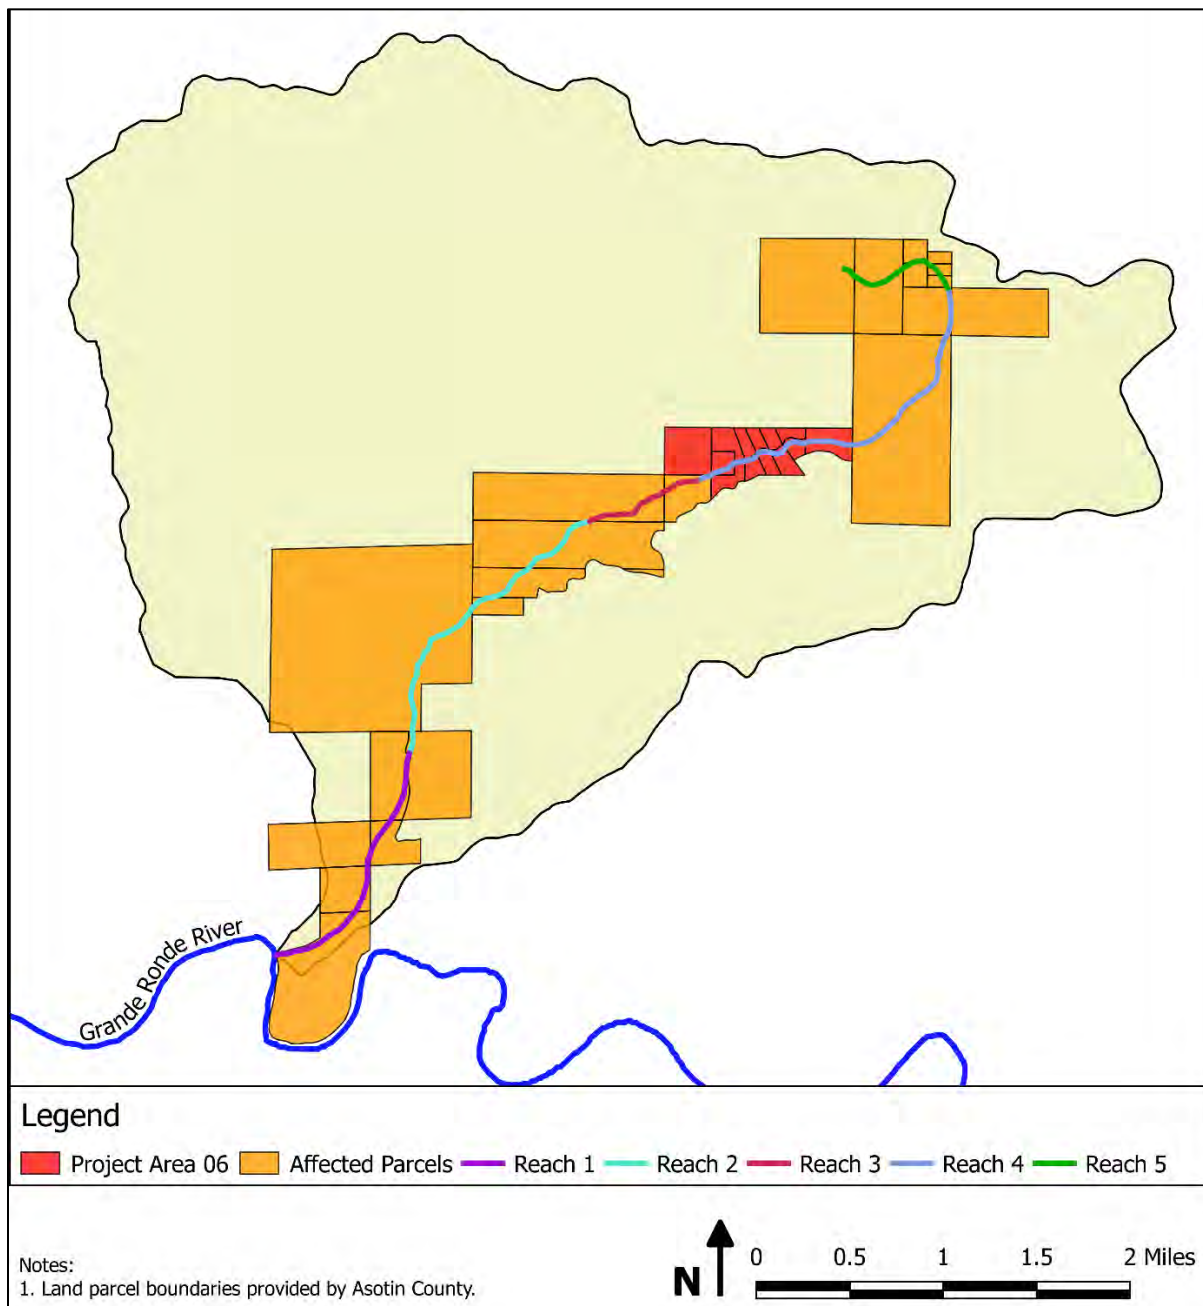
Figure 12. Location of Project Area 06 within the Rattlesnake Creek basin.

Project Area 06 (PA-06) begins at the upstream extent of designated critical habitat for steelhead and extends one mile upstream through several private parcels, ending at the boundary of Field Springs State Park (Figure 12). The channel and floodplain were heavily modified by the flood,

and are currently very active and unstable. There are frequent steep drops in elevation (Figure 13a), tall boulder berms that impose increased confinement on the creek, and excessive sediment composed mostly of boulders and large cobble where the creek goes subsurface (Figure 13b). The creek will require multiple high flow events to define a new, sustainable channel and develop a new floodplain.

There are approximately 90 pieces of LWD lodged along the valley margin. A primitive access road on river right was destroyed between RM 4.2 and 4.3, restricting access to several private parcels near the downstream end of PA-06.

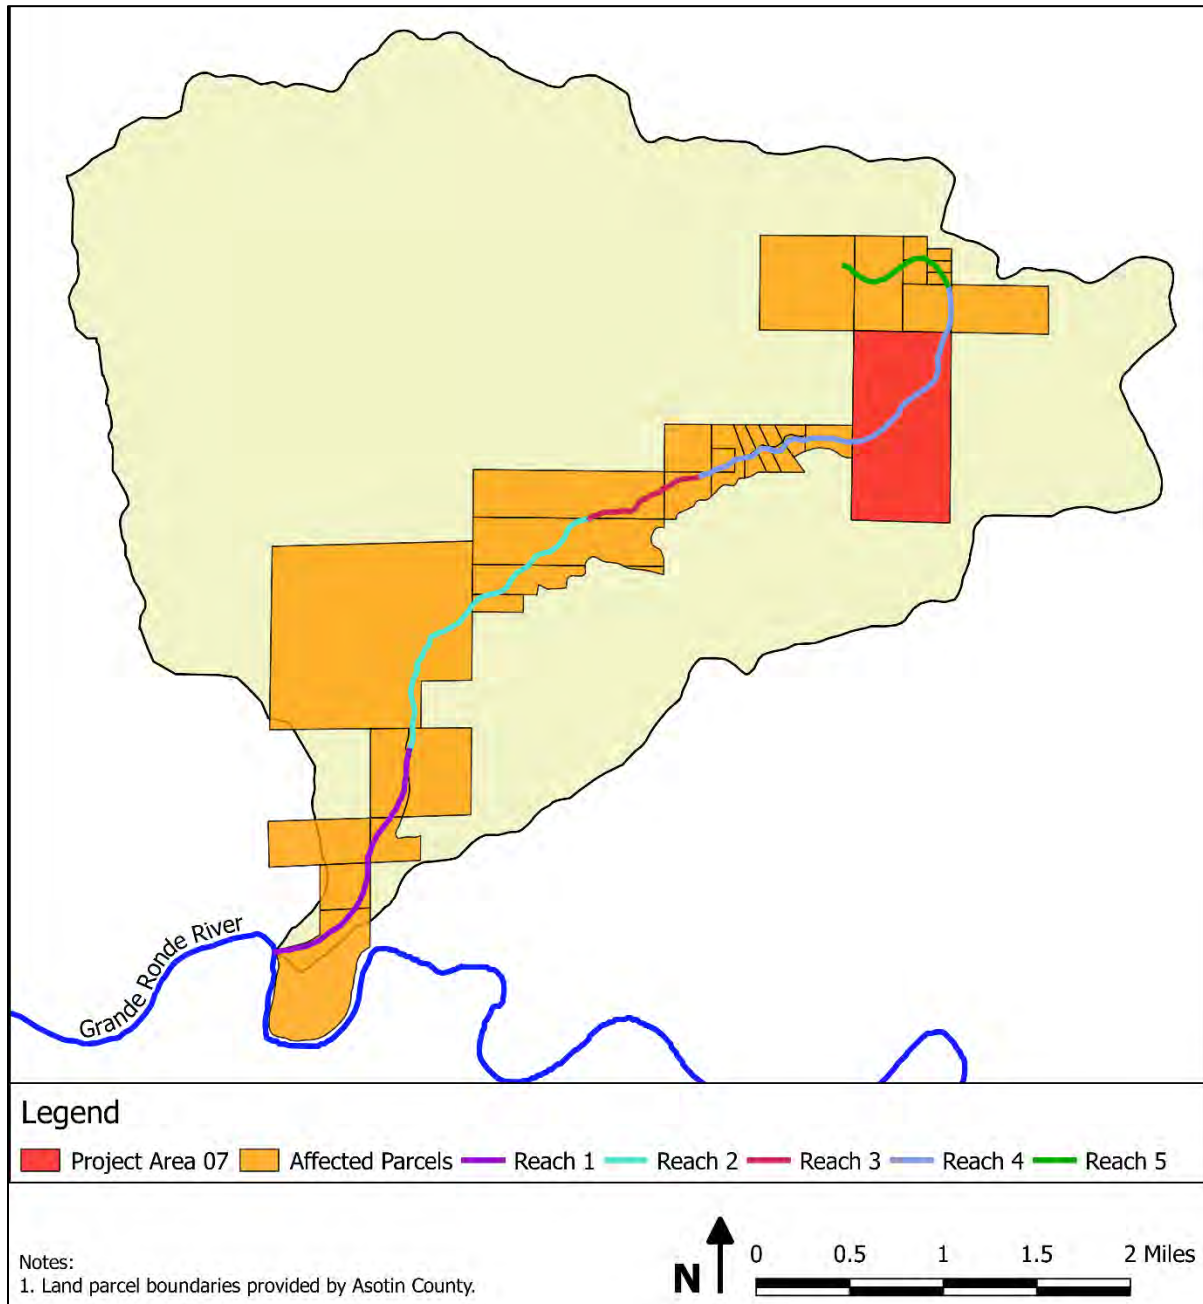
Figure 14. Location of Project Area 07 within the Rattlesnake Creek basin.

A private access road follows the creek on river right and was damaged in some areas. For example, the road between RM 5.5 and 5.6 is partially intact, but the creek is currently flowing

against the toe of a vertical cut bank supporting the road prism. It is likely that future high flows will continue to threaten the integrity of the road at this location and others like it throughout PA-07 and in downstream reaches. This road is the only access to several private parcels downstream.

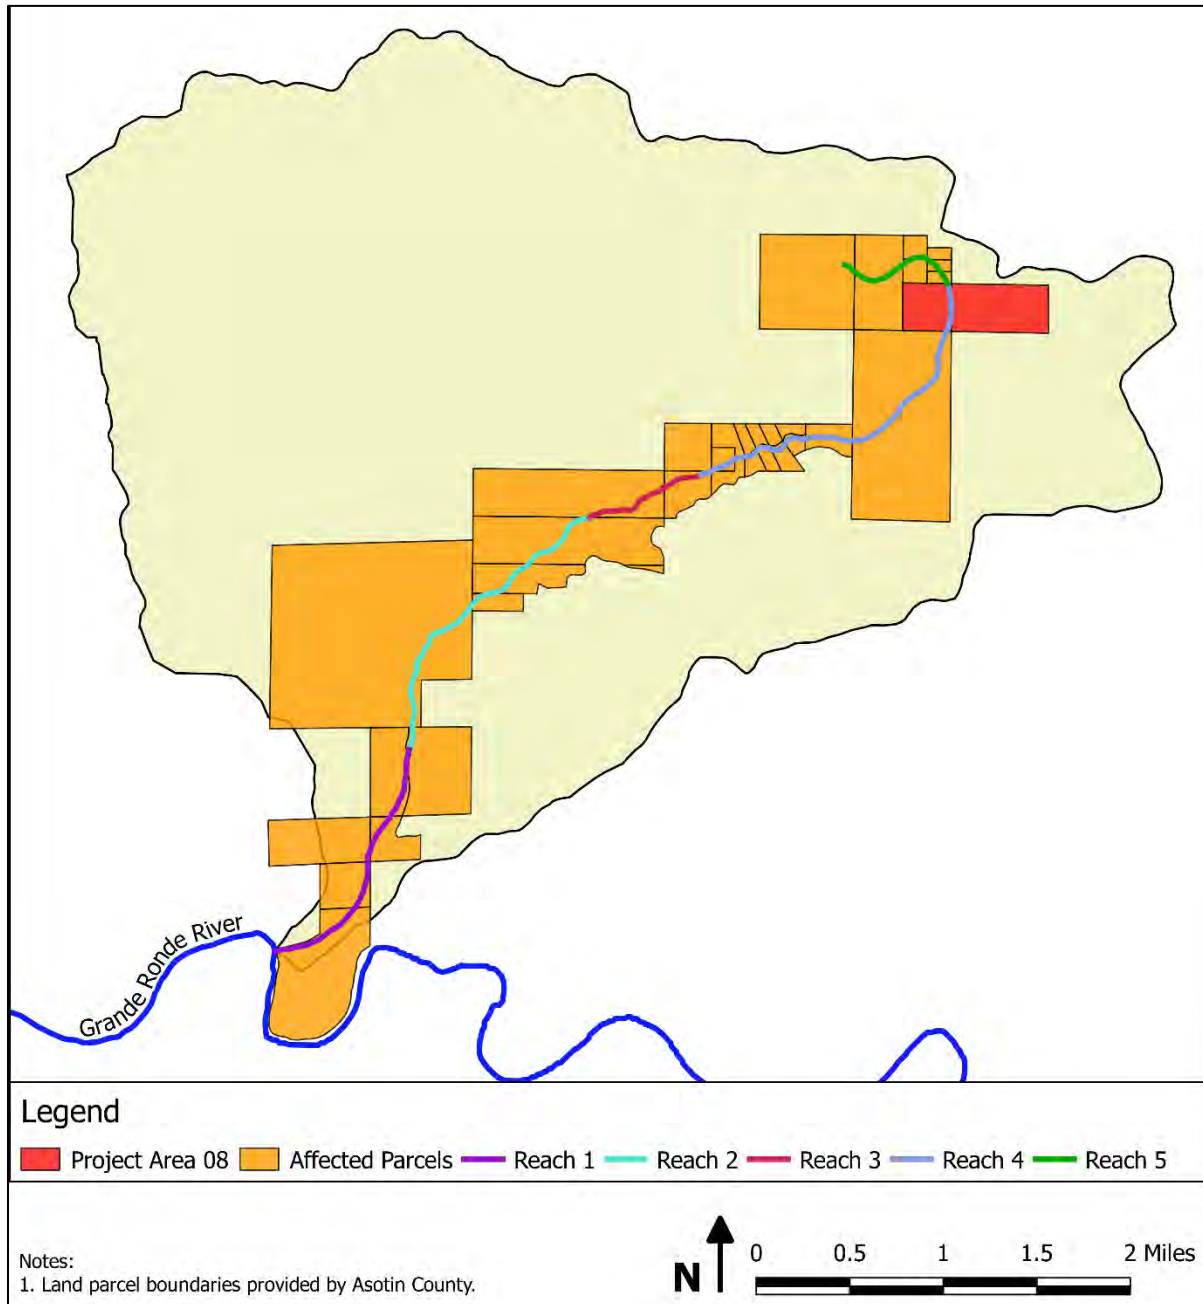
Figure 16. Location of Project Area 08 within the Rattlesnake Creek basin.

Project Area 08 (PA-08) is located within private property, starting at the boundary of Field Springs State Park and extending upstream for only 0.3 miles, ending at a private road crossing (Figure 16). The channel and floodplain has been scoured down to bedrock in most areas (Figure 17a and b), until the upstream end of a head cut near RM 6.0 (Figure 17c). Upstream of the head cut, valley gradient decreases, confinement decreases, and channel character changes to a valley-

fill meadow (e.g., Figure 17d). Because PA-08 is located high in the basin, there was not a thick layer of topsoil in the valley bottom before the flood, so even though bedrock is exposed in most areas, the overall depth of incision is not as severe as downstream reaches. Regardless of how much topsoil was present, the floodplain is damaged and riparian vegetation is mostly non-existent.

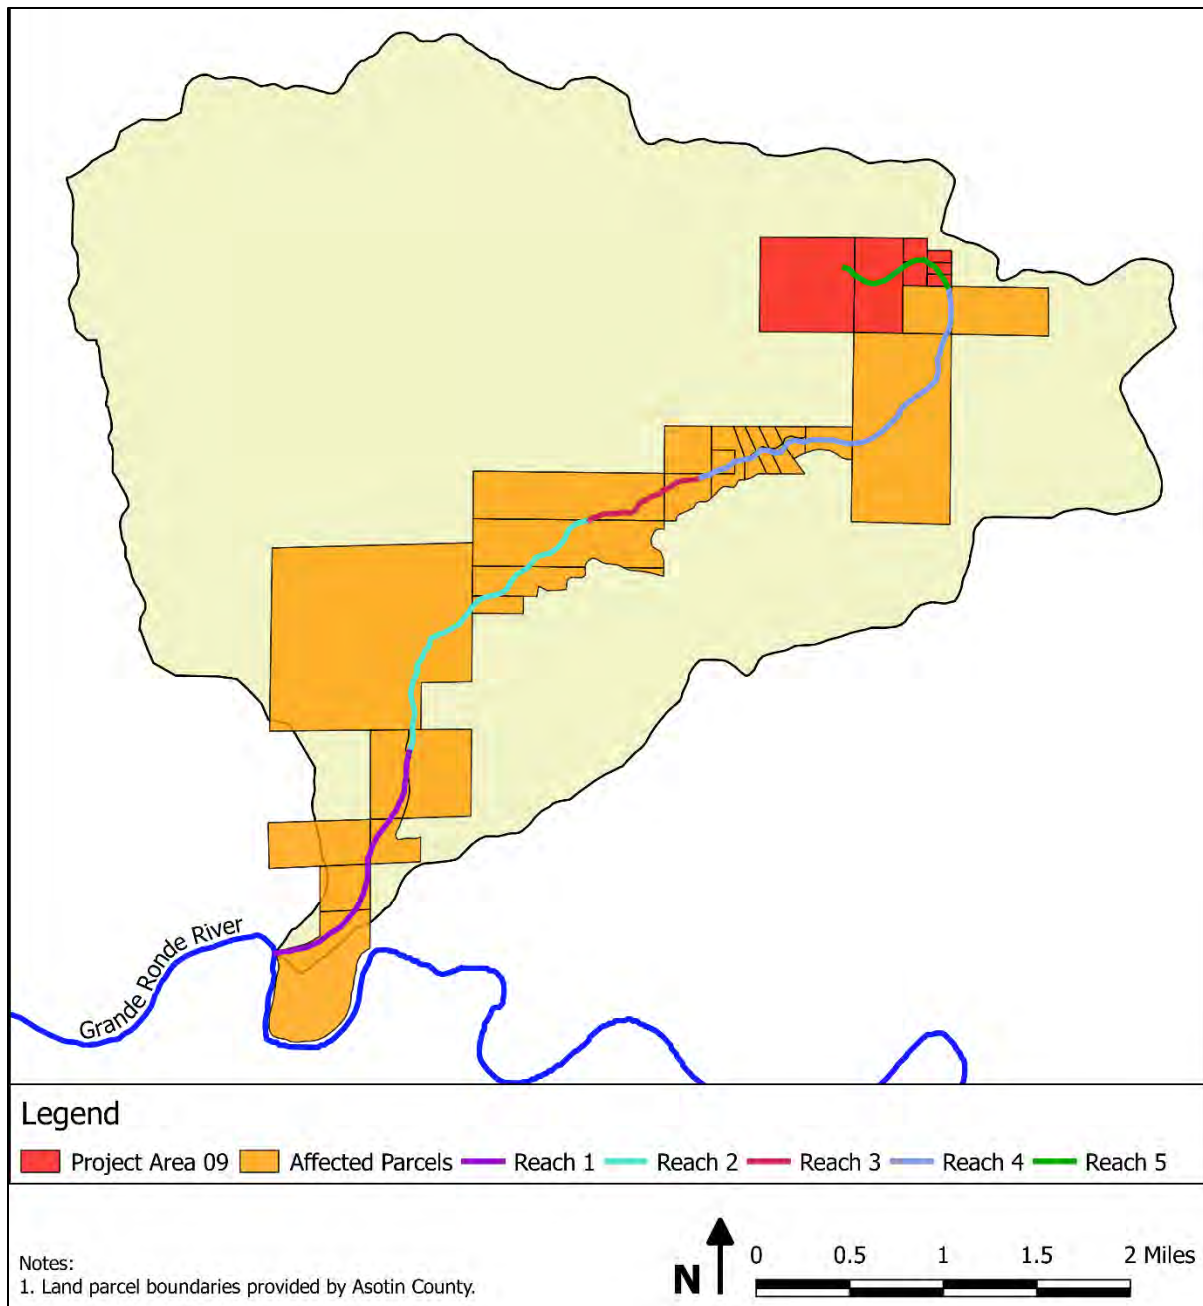
Figure 18. Location of Project Area 09 within the Rattlesnake Creek basin.

Project Area 09 (PA-09) is the only project area in Reach 5 and is entirely within private lands (Figure 18). The gradient and valley confinement are variable throughout the reach, transitioning between steep confined sections, and unconfined meadows. A pond near RM 6.5 was damaged by the flood, but remains partially intact (Figure 19a). Downstream of the pond, the valley bottom is scoured down to bedrock (e.g., Figure 19b) in most areas until the channel reaches a private road crossing near RM 6.3. A large boulder sheet was deposited downstream of the road, extending downstream nearly 0.2 RM. Some work has already been done to repair damages from the flood including creating a small dike along the channel near RM 6.2 (Figure 19c). There are several private roads with access to the parcels affected by the flood. Two roads with culverts cross the channel and both were damaged, but have been fixed or replaced. The lower culvert is clogged with sediment and backing up water upstream of the road crossing (Figure 19d). Material in the culvert appears to be mostly fines, sands, and gravel, so it may clear itself during the next high flow event; however, if the sediment is not cleared, more damage could be caused to the road and downstream reaches.
